Idaho Fall Water Supply Committee Meeting

Southwest Idaho Report

November 10, 2016

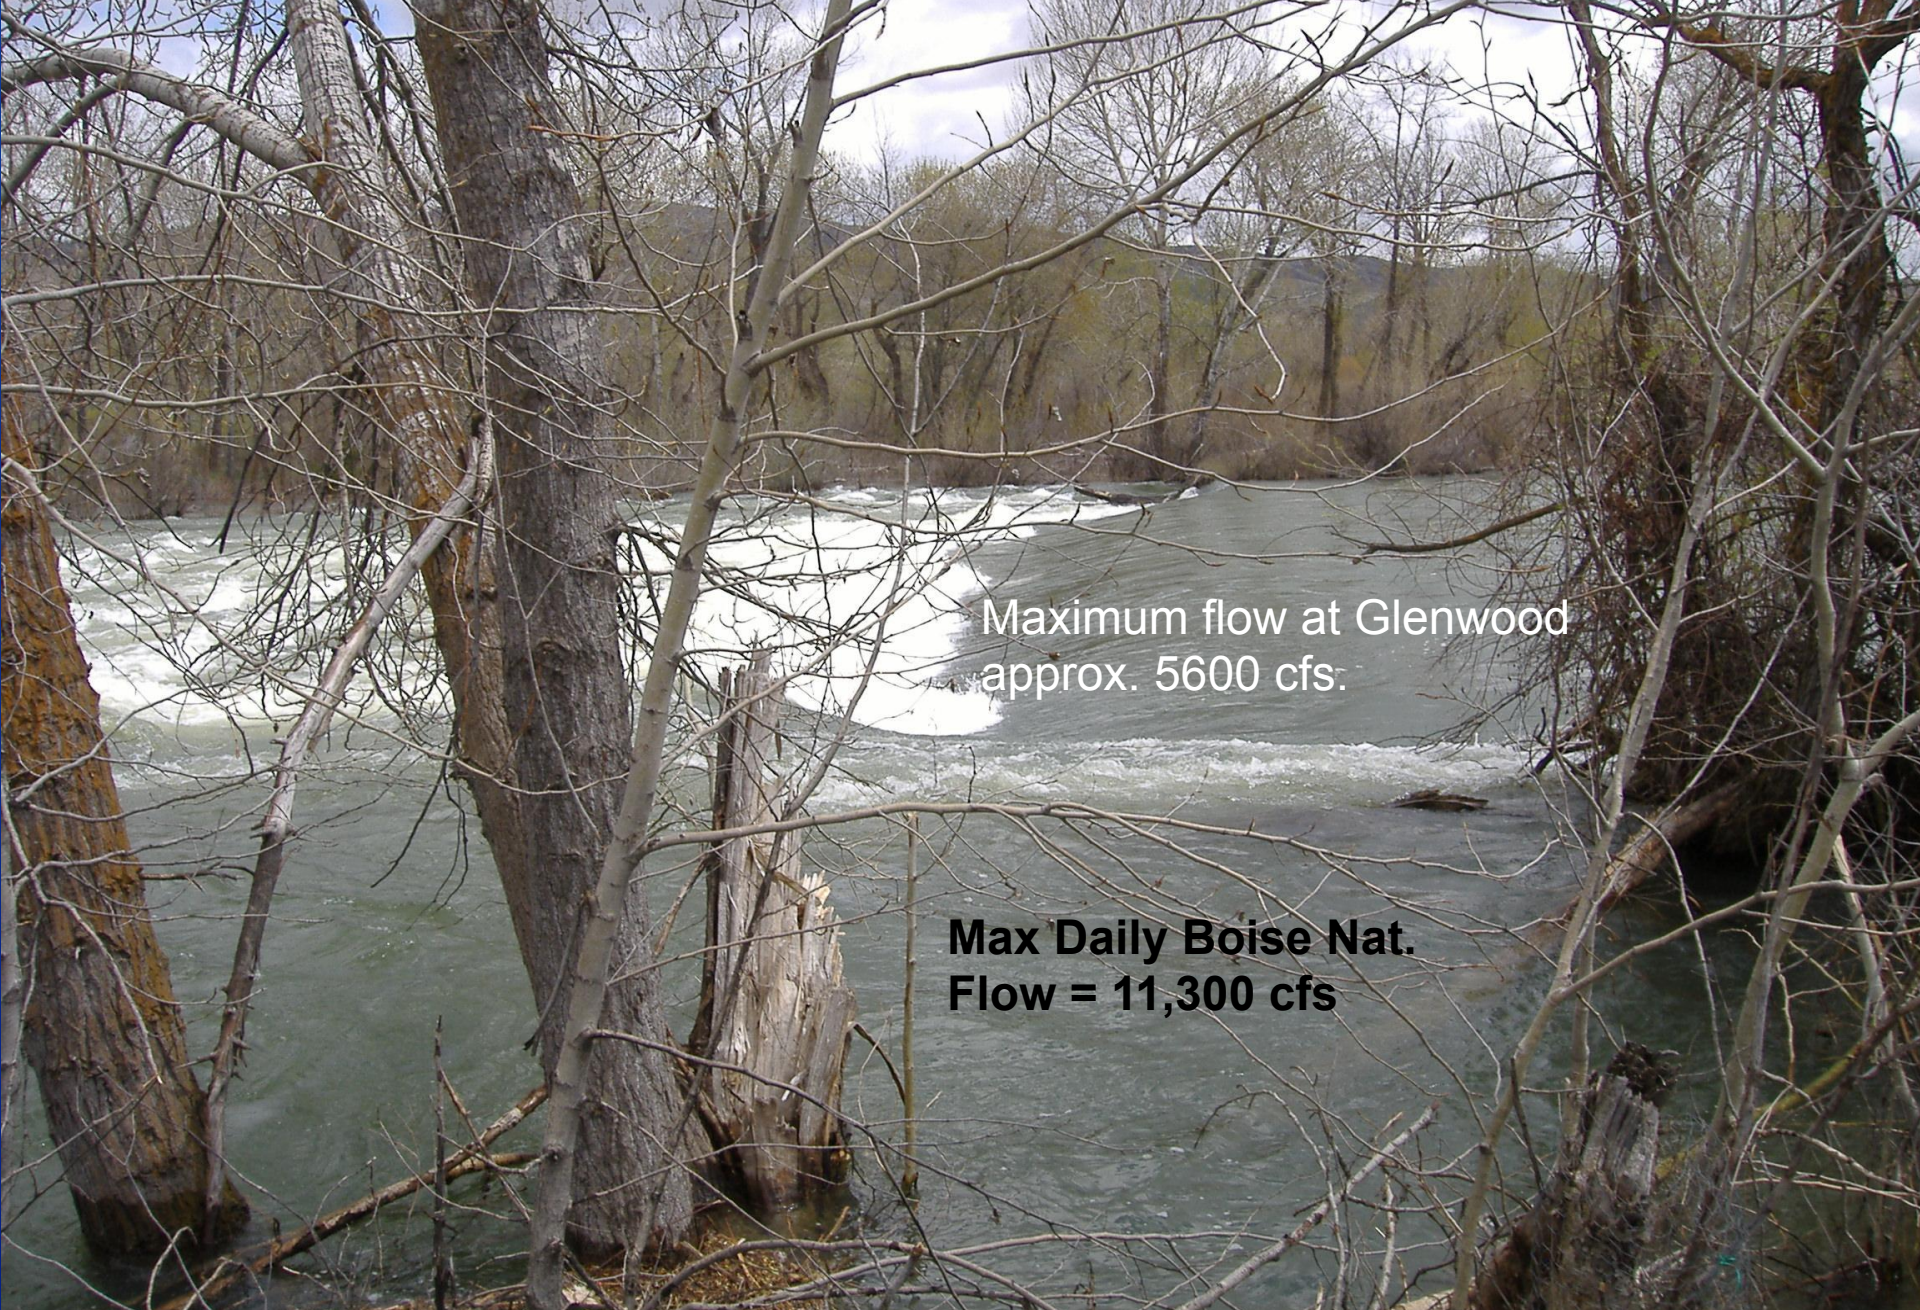
Maximum flow at Glenwood
approx. 5600 cfs:

**Max Daily Boise Nat.
Flow = 11,300 cfs**

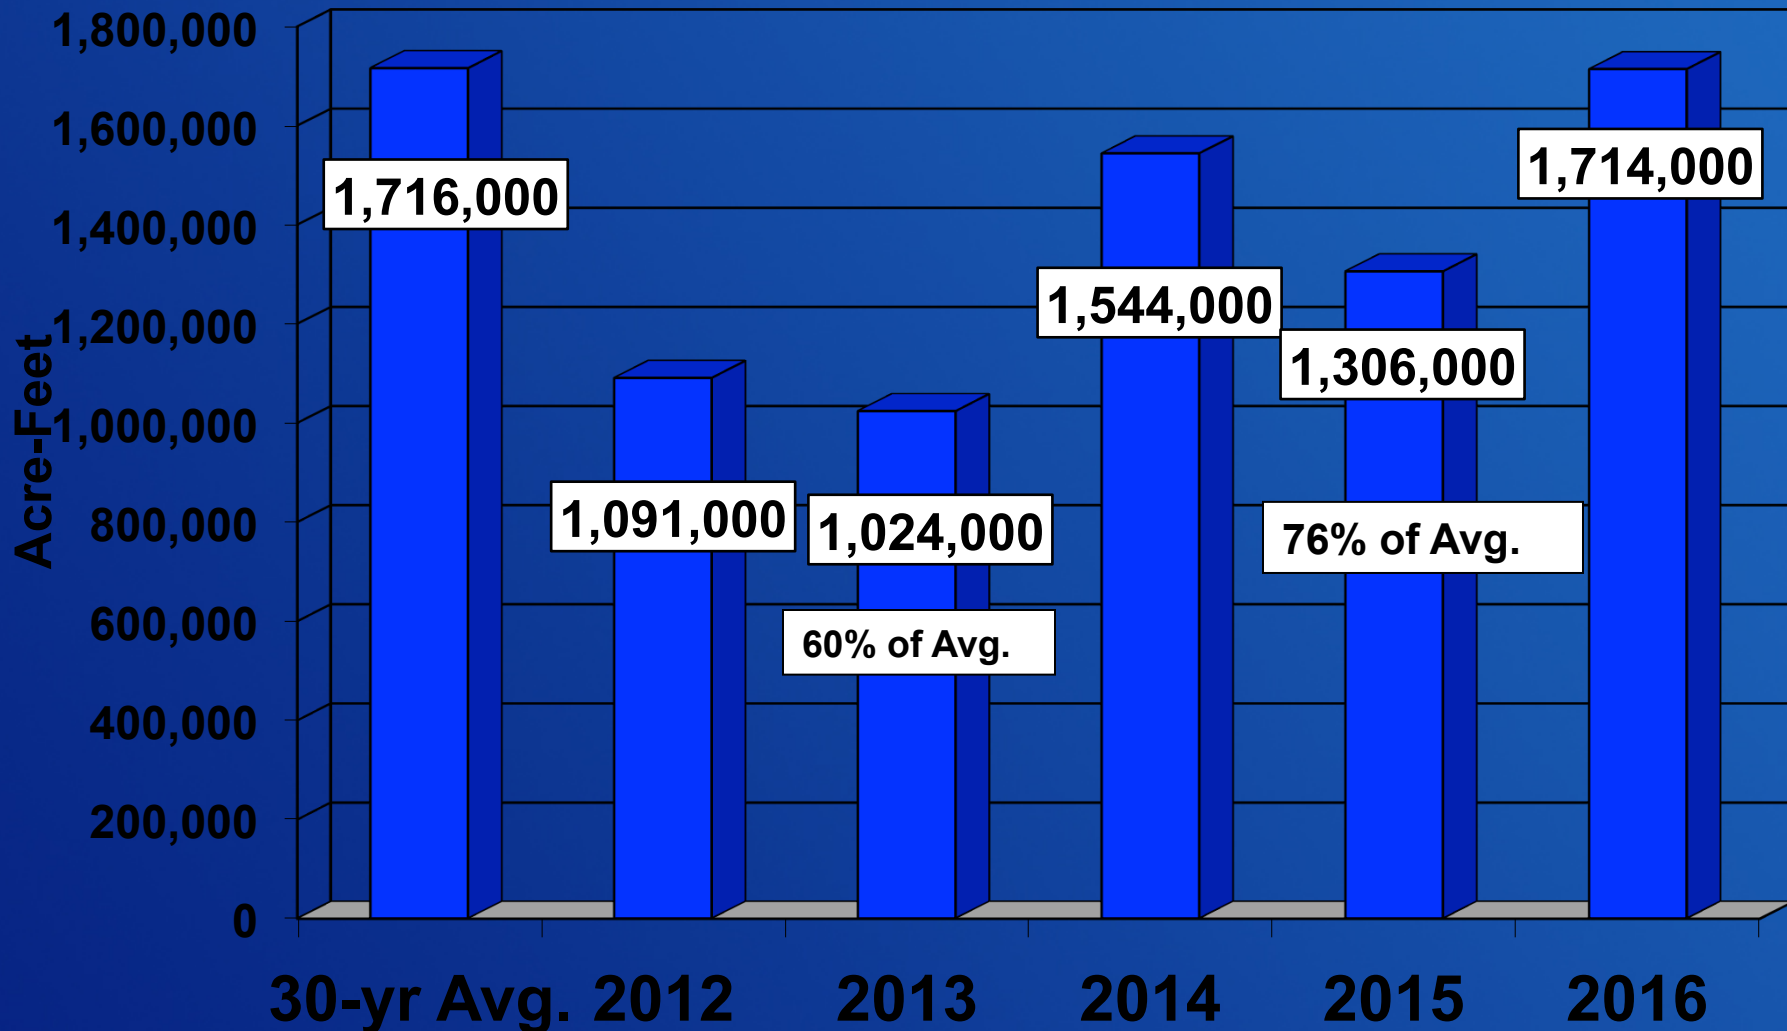
Boise Basin Runoff

Oct 1 – July 31

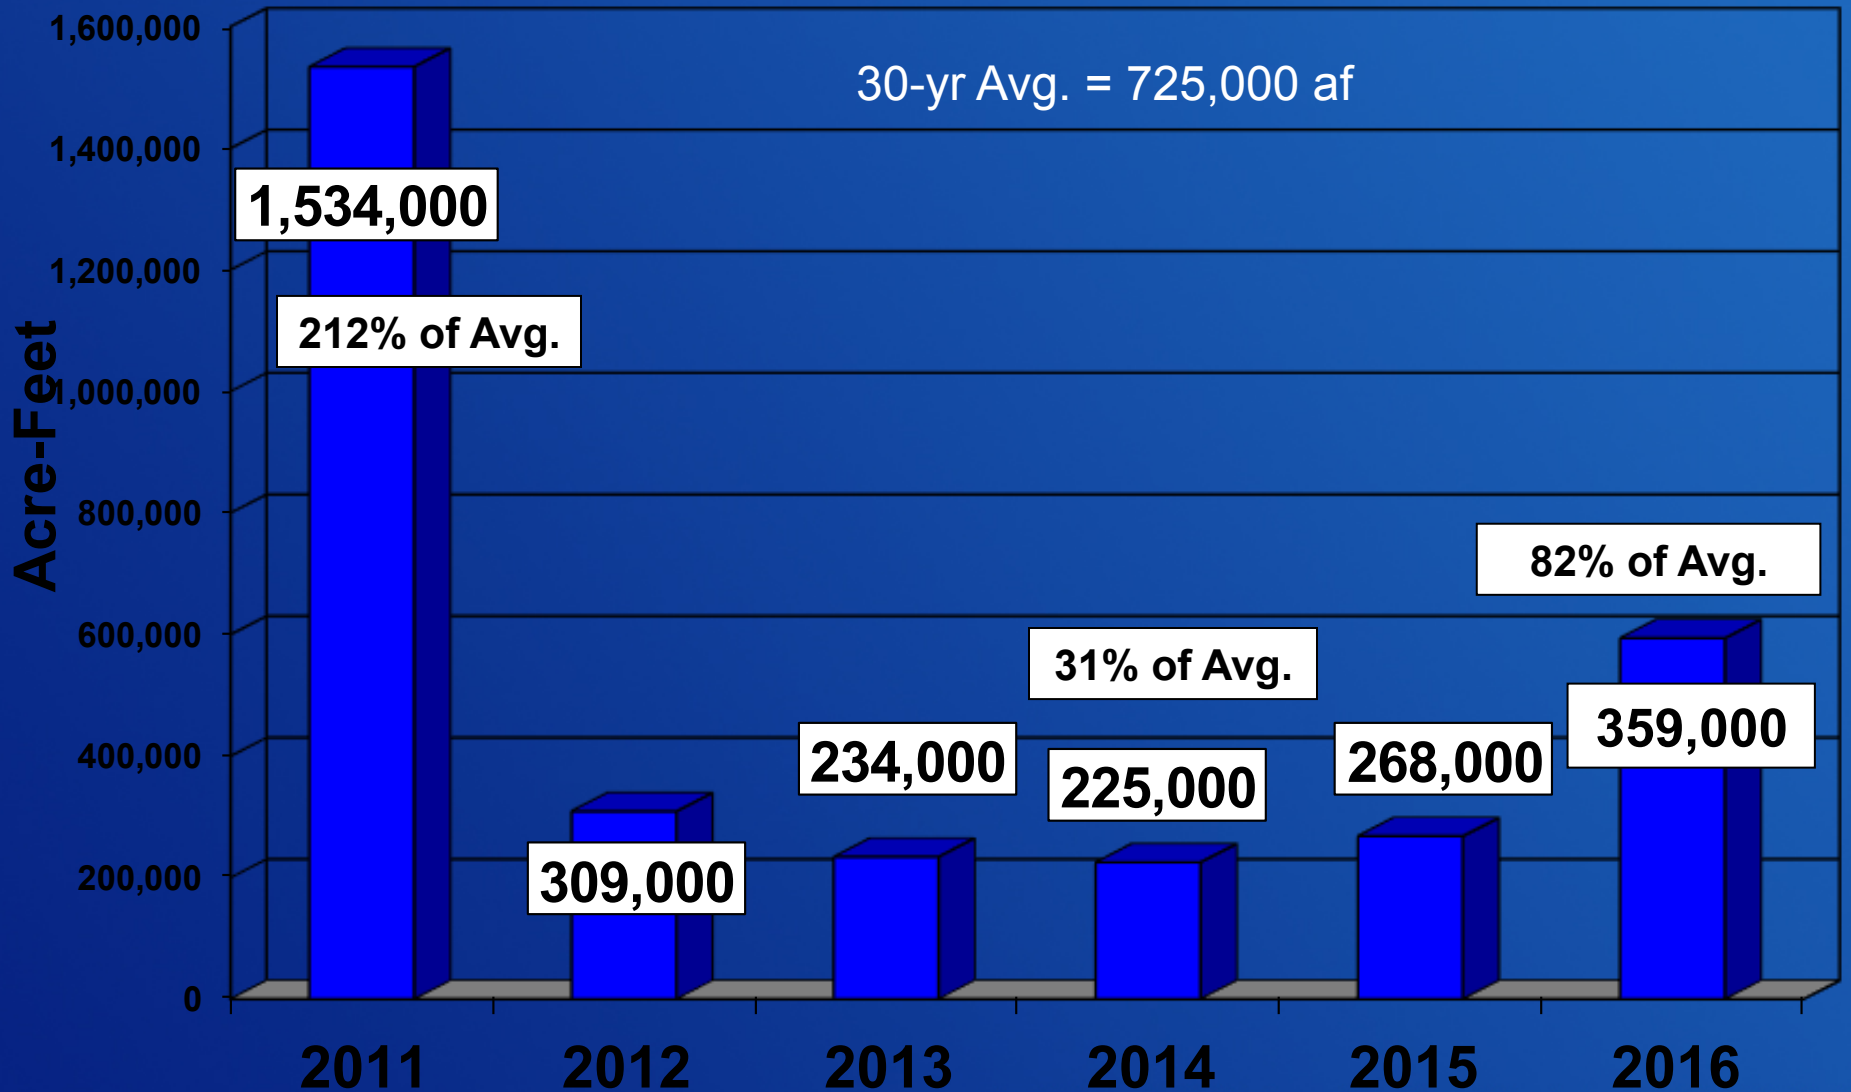
Owyhee Reservoir Inflows

April 1 – June 30
